วิชา 237-407 Failure Mechanics and Analysis

**Case Study : Failure investigation on the cracked crawler pad link**

## Failure investigation on the cracked crawler pad link

An in-service failure of traveling gear crawler pad occurred on dredger. Inspection revealed cracking of two links that connect individual pads together. Intergranular brittle fracture occurred on the links and a significant amount of chain-like and rod-like AlN inclusions were found on the intergranular fracture surfaces. Examination of mechanical properties indicates that the plasticity and impact toughness of link material are considerably lower than the specified values, indicating the brittle nature of link material. The presence of intergranular AlN inclusions resulting from considerably excessive aluminum content in link material is responsible for the brittle nature of link material. The presence of shrinkage cavities facilitated the cracking process.

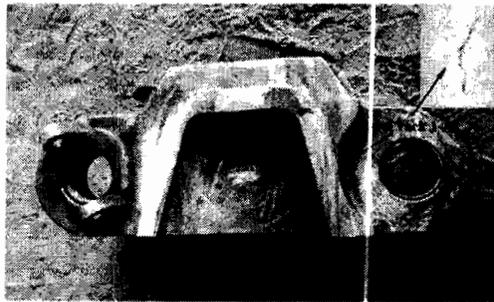
Fig. 2. Cracked link 1 (side face).

basically consistent with the neck fillet (labeled crack 1-A in Fig. 2). For link 2, cracking occurred at edge of triangle hole of the bottom of link (labeled cracks 2-A and 2-B in Fig. 3). The cracks present wavy. Crack 1-A is about 22 mm long and cracks 2-A and 2-B are about 13 mm and 73 mm respectively.

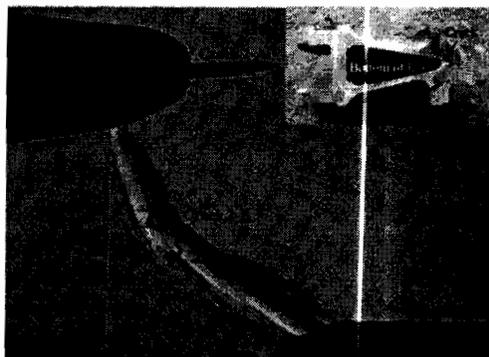
Fig. 3. Cracked link 2 (end face).

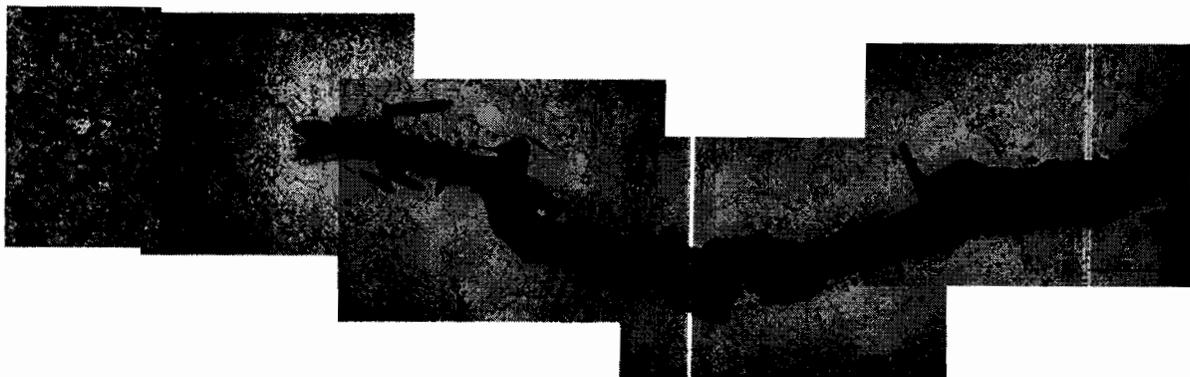
**Fig. 5.** Cross sectional morphology of crack 1-A.

Microstructure in various regions was observed by OPM. The observation results revealed the microstructure of the core is composed of tempered martensite (Fig. 4), which is normal texture of quenched and tempered link material. The sectional sample normal to crack 1-A was observed (Fig. 5). It can be seen that the external section of crack 1-A is wider and a thick oxidation film is filled in crack. Oxidized surface of the crack confirms hot tearing phenomenon [1]. The inner section of crack 1-A is shallow. The thicker decarburized layer consisting of ferrite was observed at both flanks of the external section. However, no decarburized layer was found at both flanks of the inner section, which exhibits normal microstructure in accordance with the matrix microstructure. It is suggested that crack 1-A had produced before quenching and propagated further from the external to the inner during quenching process.

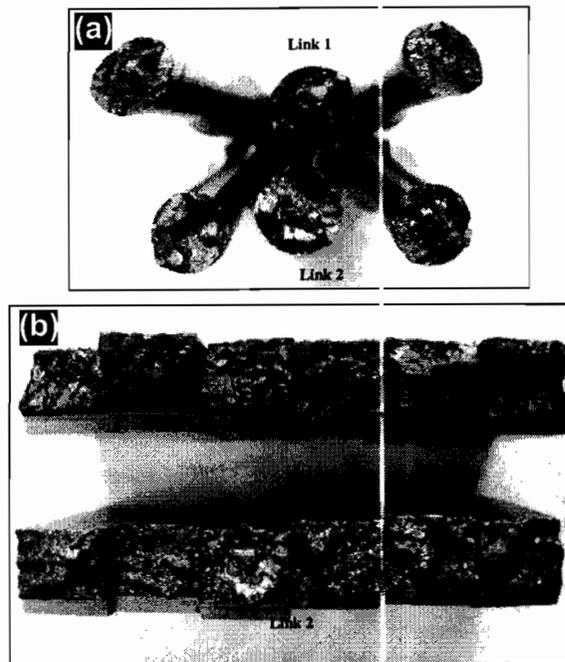
From the fracture morphology of the tensile and impact samples, the fracture surfaces are rough and crystalline and intergranular fracture features were exhibited (Fig. 6). No obvious fiber region and shear lip were found.

Fig. 6. Macro-fractures of tensile and impact testing samples: (a) tensile testing samples; (b) impact testing samples.

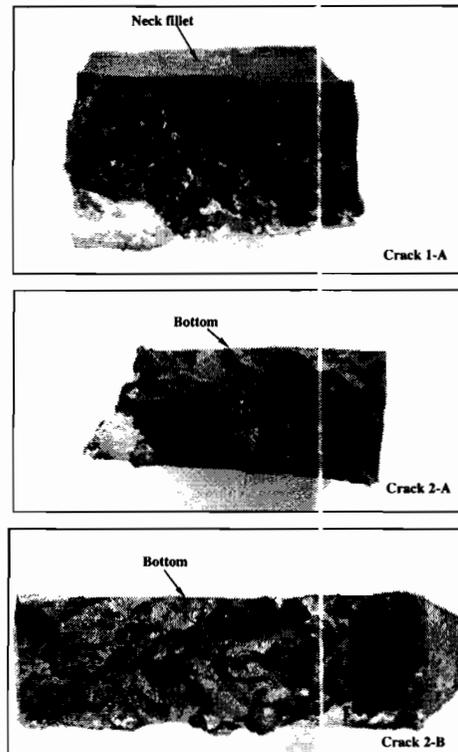
Fracture surfaces were prepared by opening cracks 1-A, 2-A and 2-E of the links. All the fracture surfaces have similar macro-features detailed as follows (Fig. 7):

- (1) The fracture surfaces are very rough and sustained discolouration showing oxidation tan.
- (2) The fracture surfaces exhibit intergranular fracture features and the grain size is very coarse, similar to the fracture appearance of tensile and impact samples.
- (3) No radiating crack propagation marks were found on the fracture surfaces, which appear usually on the quenching-cracking fracture [2], so cracking resulting from the quenching may be excluded.

Fig. 7. Macro-fractures of cracked links.

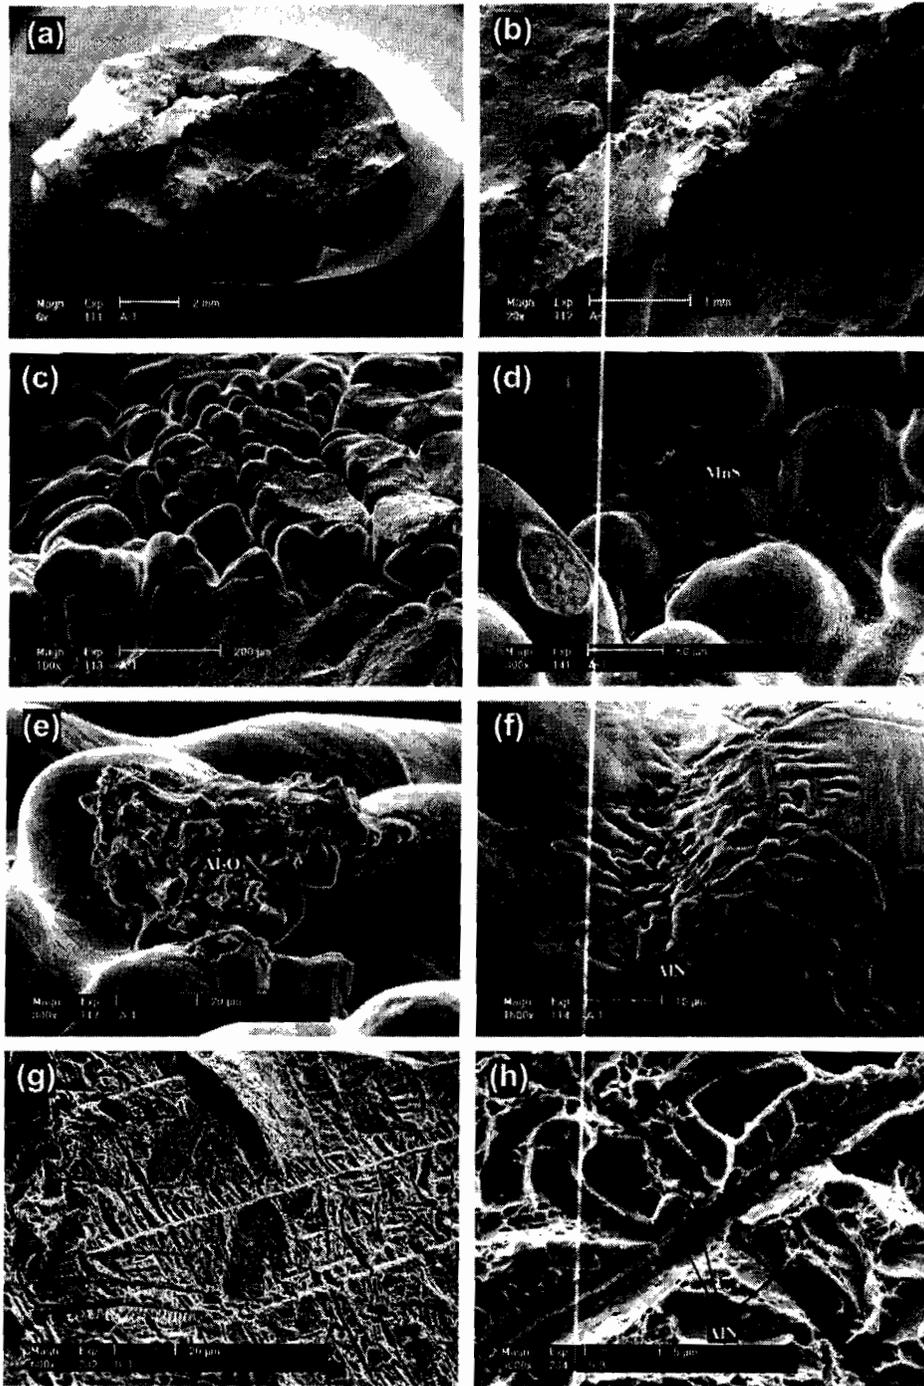
It is difficult to reveal the fracture features of the failed links due to a thick oxidation covering on the fracture surface. A penetrating fractography investigation were performed on fracture surfaces of the tensile samples by SEM. Similar micro-features were revealed on the six fracture surfaces and representative fracture morphologies are shown in Fig. 8. The fracture surface reveals intergranular features with the coarse grain size (Fig. 8a) and the shrinkage cavities within which dendritic lobes [3] are clearly seen (Fig. 8b–d). Inclusions are present within dendritic lobes (Fig. 8d), which were revealed to be MnS by EDAX analysis (Fig. 9a). Slag inclusions were found on the fracture surface (Fig. 8e), which are demonstrated to be  $Al_2O_3$  by EDAX analysis (9b). "Suture-like" morphology was present on the dendritic lobes, which is composed of chain-like and rod-like inclusions (Fig. 8f). And straight traces with some orientations are exhibited on the intergranular fracture surfaces (Fig. 8g). By high-powered magnification observation, chain-like and rod-like inclusions are also present on the bottom of straight traces (Fig. 8h). The chain-like and rod-like inclusions are demonstrated to be the AlN phases by EDAX analysis (Fig. 9c). It is suggested that the intergranular brittle fracture of the link materials is related to the presence of chain-like and rod-like AlN inclusions [4–6].

**Fig. 8.** SEM observations on fracture surfaces of tensile samples: (a) general view showing intergranular fracture and coarse grains, (b) showing shrinkage cavities, (c) showing dendrite lobes, (d) showing inclusions within dendrite lobes, (e) showing slag inclusions, (f) showing "suture-like" morphology, (g) showing straight traces, and (h) showing inclusions at the bottom of straight traces.

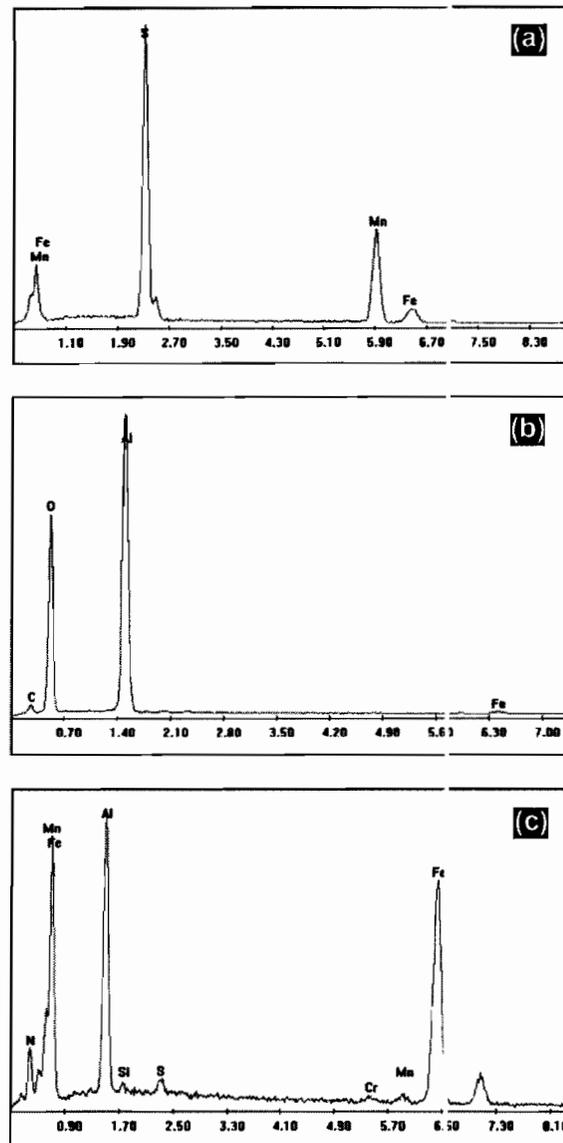
Fig. 9. EDAX spectrum taken from the inclusion regions of Fig. 8: (a) inclusion region of Fig. 8d, (b) inclusion region of Fig. 8e, and (c) inclusion region of Fig. 8h.

metallurgical inclusions AlN were found on intergranular fracture surfaces, which is related to considerably excessive Al content in the link material resulting from excessively adding Al in steelmaking. The presence of AlN phases in the grain boundary intensely weakened boundary strength and decreased the impact toughness and plasticity of the material to lead to brittle intergranular fracture of the link. Further, the presence of shrinkage cavities facilitated the cracking process [5].

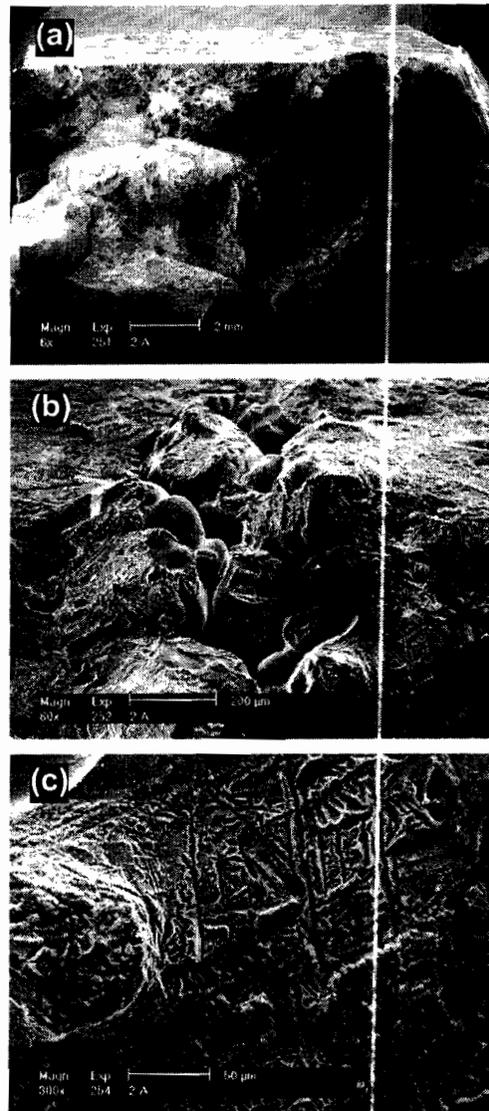
The intergranular fractures with coarse grains and shrinkage cavities with dendritic lobes were also revealed on the cracked links (Fig. 10a and b). The fracture surfaces of the failed links were covered with a layer of oxidation, but the straight traces with lots of AlN inclusions similar to ones on the fracture surfaces of tensile samples were also found (Fig. 10c). It is suggested that the cracking failure of the links are also related to the presence of inclusion AlN phases.

**Fig. 10.** SEM observations on the fracture surfaces of failed link (link 2, crack 2-A): (a) general view showing intergranular fracture and coarse grains, (b) showing dendritic lobes, and (c) showing straight traces.
