การสอบปลายภาค ประจำภาคการศึกษาที่ 1

วิชา 237-407 Failure Mechanics and Analysis

Case Study: Failure analysis of a car suspension system ball joint

Failure analysis of a car suspension system ball joint

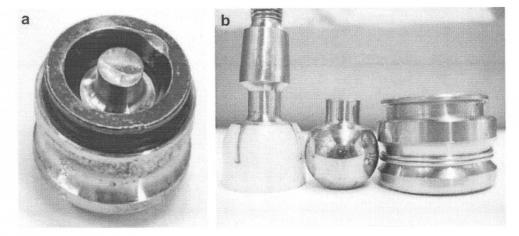
Fig. 1. Ball joint element. (a) Failed ball joint in the cage. (b) Failed and new ball joints out of the cage.

This study describes the analysis and investigation of the causes of the sudden failure of a MacPherson strut suspension system ball joint. The axis of the ball joint element showed a complete fracture which occurred midway between the top and bottom section changes of the element, as shown in Fig. 1. The failed ball joint element is shown in Fig. 1, along with a ball joint element not previously used, in order to show the height at which the fracture occurred in the element.

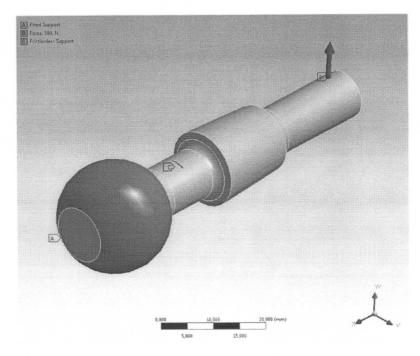
Fig. 6. Ball joint boundary and loading conditions used in the numerical analysis. A: Fixed support; B: Load 500 N; C: Fixed support.

- 1. A fixed contact in zone A (ball), shown in blue³ color in Fig. 6.
- 2. A lateral load B, assumed constant in this analysis to simplify the modeling, with a value of 500N and applied at the end of the element. This load value was used according to the experimental study of Ryu et al. [9], who found a value of lateral load of approximately 500N for a suspension system similar to the one studied here, so it is considered that this value of load represents a realistic estimate of the load applied to the element.

- 3. A lateral contact support patch in C, corresponding to the support of the axis of the ball joint element with its cage. This contact patch support was applied between the ball and the end of the element where the failure occurred (Fig. 1) with a rectangular shape as the real shape of contact of the ball joint element against its cage. The rectangle on the contact region had 1 mm thick by 3 mm long around the perimeter of the ball joint element.

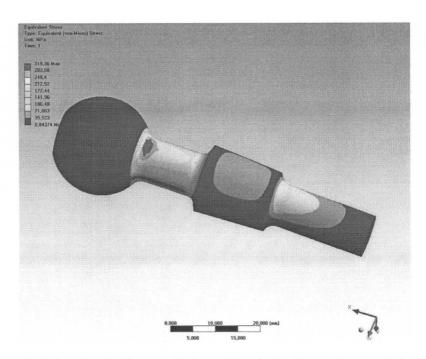
$\textbf{Fig. 7.} \ \ \textbf{Equivalent Von Mises stress distribution of the ball joint without contact support in C.} \\$

Fig. 7 shows the stress distribution on the ball joint element without the contact support patch C in place. In this case the maximum stress was found on the section change between the ball and the axis. This stress reached a maximum value of 319 MPa approximately. On the other hand, Fig. 8 shows the stress distribution on the element including the contact support

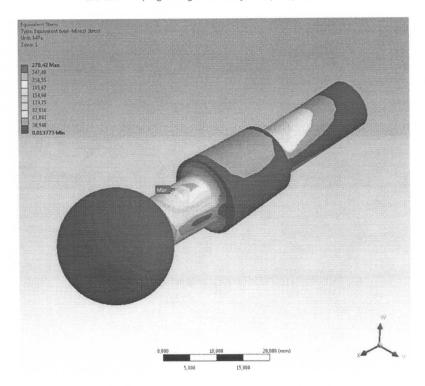
Fig. 8. Equivalent Von Mises stress distribution of the ball joint with contact support in C.

patch C in the calculations. In this case the maximum stress was found on the contact region between the axis of the element and its cage. This stress reached a maximum value of 278 MPa approximately, which is lower than the bulk fatigue endurance limit of this steel under normalized conditions, which reaches a value of 416 MPa [7]. However, this stress is close to the endurance limit found using Murakami's Eq. (1) for the acicular ferrite present in the grain boundaries of the material. Also note that the place where this stress is reached corresponds with the place where the fracture occurred in the ball joint element (see Fig. 1). The smooth beach marks accompanied by ratchet marks and a small final fracture zone (one quarter of the cross section of the element) confirm that the element suffered high stress low cycles fatigue conditions initiated at the acicular ferrite on the grain boundaries, followed by fatigue crack growth.

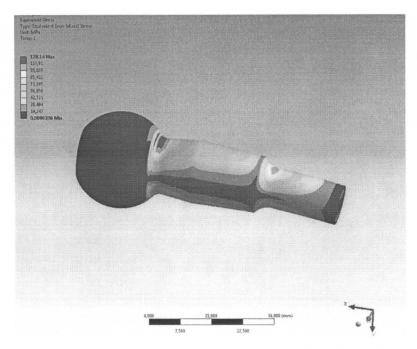
Fig. 9. Equivalent Von Mises stress distribution of the modified ball joint without contact support in C.

In order to reduce the contact stresses on the ball joint element, a change on the geometric design of the element was proposed. In the proposed design, the cross section of the element was increased as sown in Fig. 9. This element was modeled using the same loading and boundary conditions employed for the failed element, as shown in Fig. 6. Fig. 9 shows the stress distribution on the proposed ball joint, being modeled without the cage support. In this case the maximum stresses were found on the section change between the ball and the axis of the element, with a maximum value of 128 MPa approximately. On the other hand, Fig. 10 shows the stress distribution of the proposed design considering the cage contact patch C. In this case the maximum stress was found on the cage contact, as expected, with a maximum stress value of 151 MPa, which is almost half the value reached in the same zone by the failed ball joint and well beyond the fatigue endurance limit of the material.

It is then suggested to modify the geometry of the ball joint to increase the loading section and reduce the contact stresses with the cage. It is also suggested to evaluate the heat treating processing conditions followed on the manufacture of the element to avoid the formation of acicular ferrite which further reduces the fatigue endurance limit of the element.
