การสอบปลายภาค ประจำภาคการศึกษาที่ 1  
 วันที่ 8 ตุลาคม 2555  
 วิชา 237-407 Failure Mechanics and Analysis

#### Case Study : *Case internal oxidation and intergranular fracture of carburized splined-shaft*

## Case internal oxidation and intergranular fracture of carburized splined-shaft

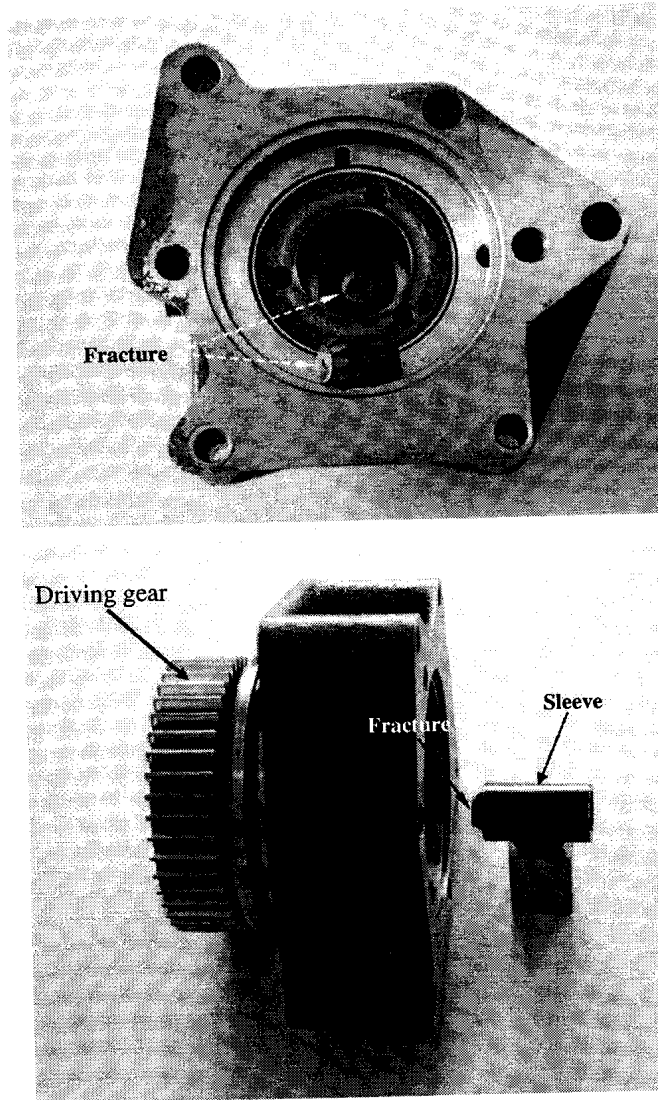
It was reported that two truck diesel engine splined-shafts fractured in service of merely 7–8 h. One of the as-received auxiliary driving assemblies containing a fractured splined-shaft is shown in Fig. 1. The failed splined-shafts are made from 20MnCr5 steel. The external surface of spline-shaft is required to be carburized. The treatment was conducted at 930 °C for 4 h, then pre-cooled at 840° for 15 min, directly quenched in an oil bath, and tempered at 180 °C for 2 h. The surface hardness is specified as HV<sub>10</sub> 675–770 and the depth of carburized layer as 0.30–0.80 mm.

Fig. 1. Failed auxiliary driving assemble.

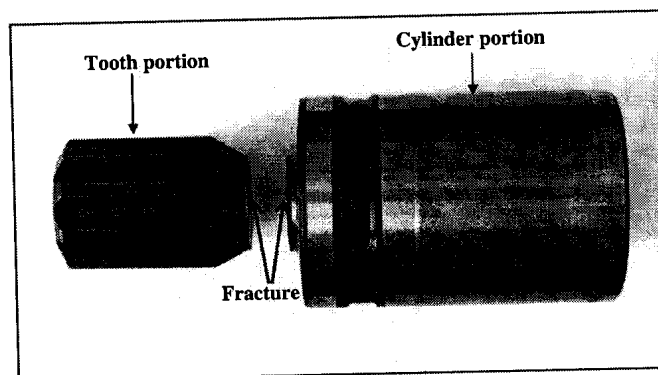
Fig. 2. Fractured splined-shaft.

The failed splined-shaft is shown in Fig. 2. It can be seen that the transverse fracture occurred at the root fillet between the tooth portion and the cylinder portion. The fracture surface is perpendicular to the axis of the splined-shaft and no obvious macro plastic deformation was observed. The fracture surface is relatively flat, exhibiting sliver grey tint and the located metal gloss resulting from mutual rubbing of the fracture surfaces. High-magnified observation revealed that the fracture surface close to the center hole is rough and slight convex, characterized by a “center of twist” [9] and the circular shear traces surrounding the center of twist were found on the fracture surface (Fig. 3). It is suggested that the failure mode of the splined-shaft is torsion fracture and twist final fracture zone is situated at the fringe of center hole. However, it is difficult to determine the location of crack origin and the direction of crack propagation from the macro observation.

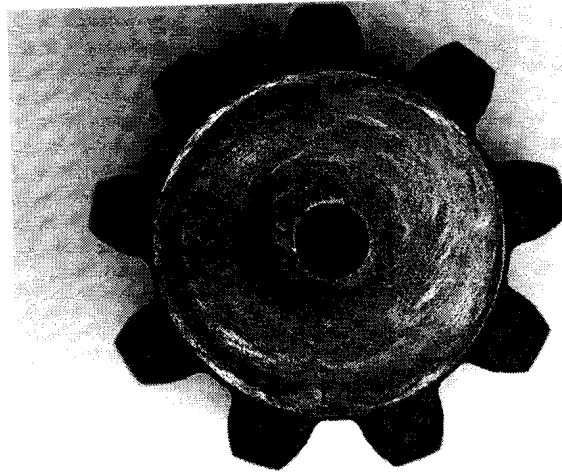
Fig. 3. Macro-fracture of splined-shaft.

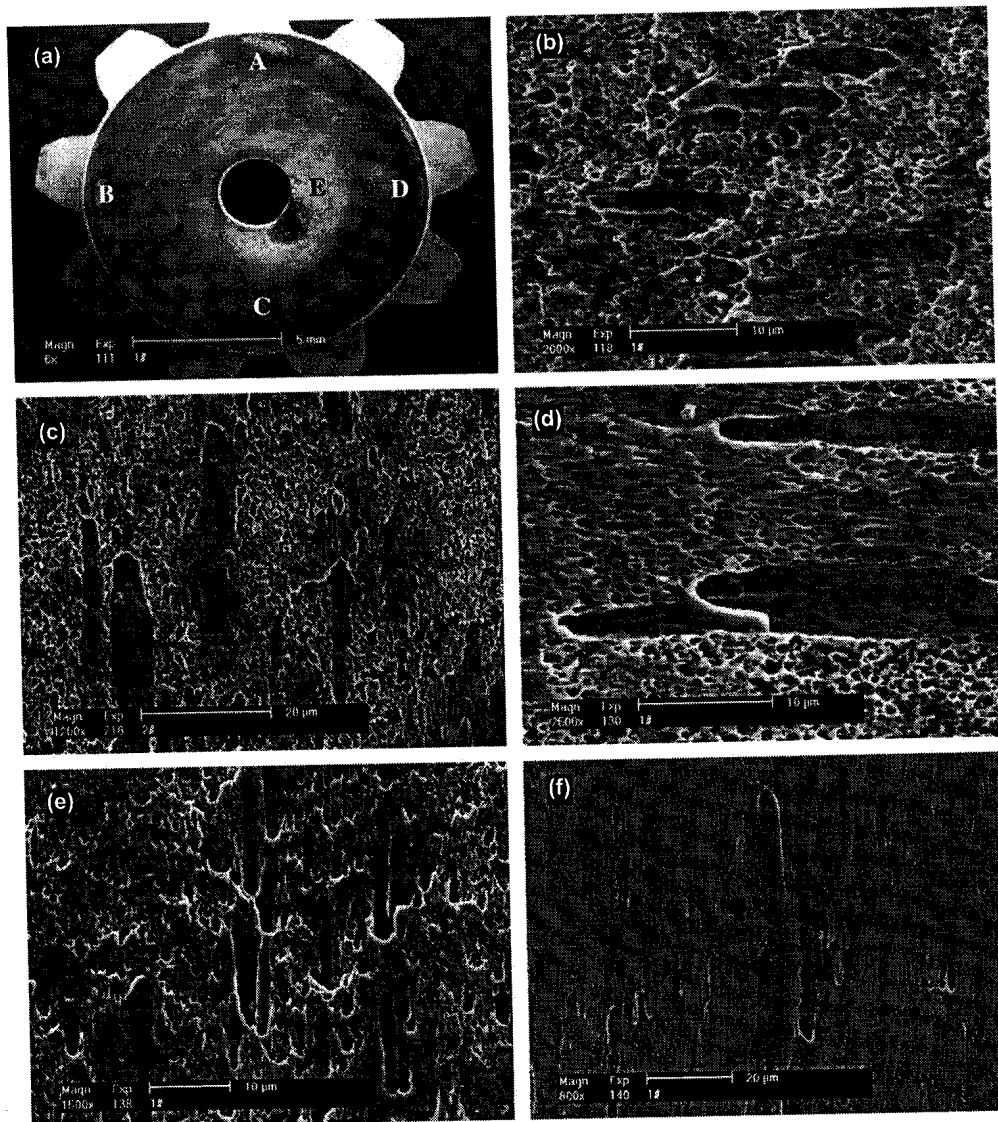
Fig. 4. SEM observation on fracture surface showing parabola dimples: (a) general view, (b) zone A, (c) zone B, (d) zone C, (e) zone D, and (f) showing scrape marks.

SEM observation indicates that the fracture surface exhibits generally circular parabola shallow dimples (Fig. 4). Obvious contact scrape marks along the dragged direction of parabola dimples appear in the local regions of fracture (Fig. 4f). Unfortunately, the outer periphery of fracture surface was worn severely, so fractographic features representing a carburized sur-

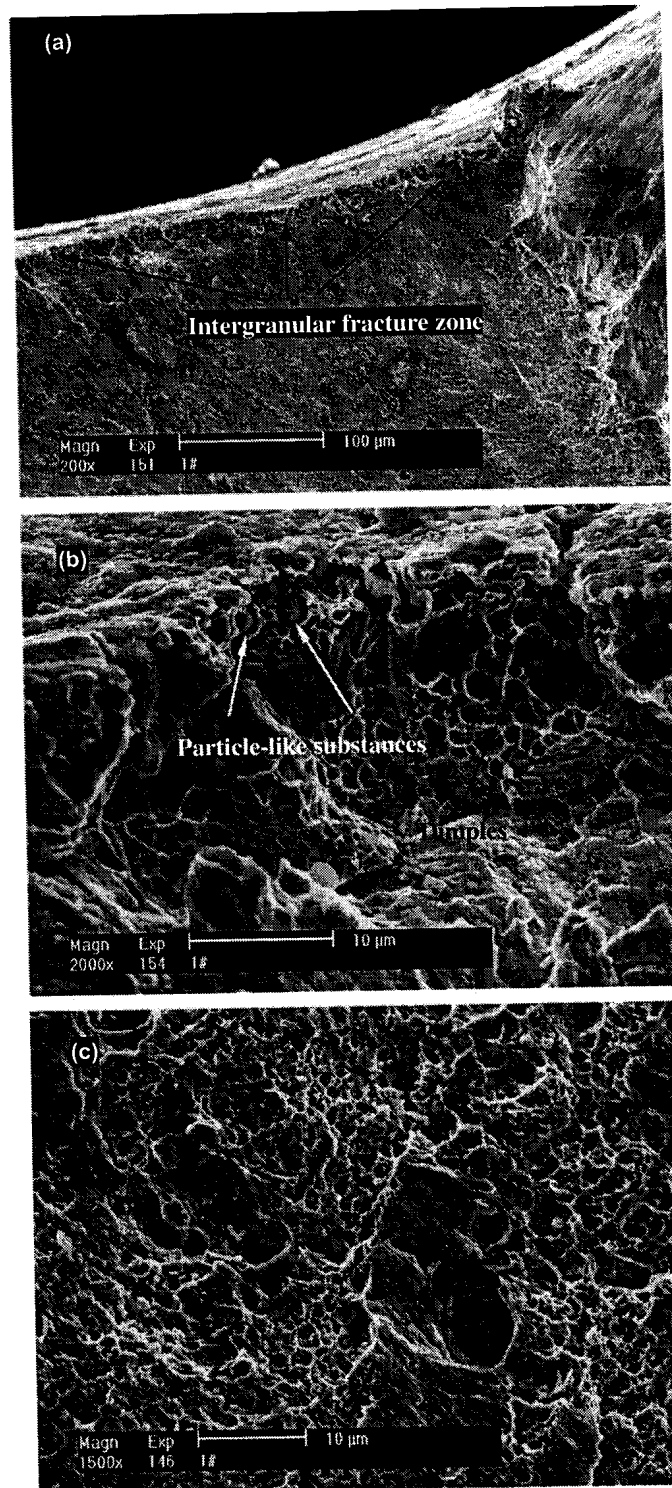
**Fig. 5.** SEM observation on fracture surface close to the internal hole: (a) general view on intergranular fracture region, (b) showing intergranular facets associated with dimples and precipitates, and (c) showing dimples morphology in the instantaneous region (E region in Fig. 4).

face was not revealed. It is noted that in the located region close to the internal hole the fracture morphology is brittle, and in particular, intergranular, as shown in Fig. 5a and b and intergranular fracture extends to about 20  $\mu\text{m}$ . The intergranular facets were found associated with dimples or ductile tears [10,11], and some particle-like substances were found on the intergranular facets (marked by arrows in Fig. 5b). Additionally, in the instantaneous fracture region close to the hole, deeper parabola dimples were observed (Fig. 5c).

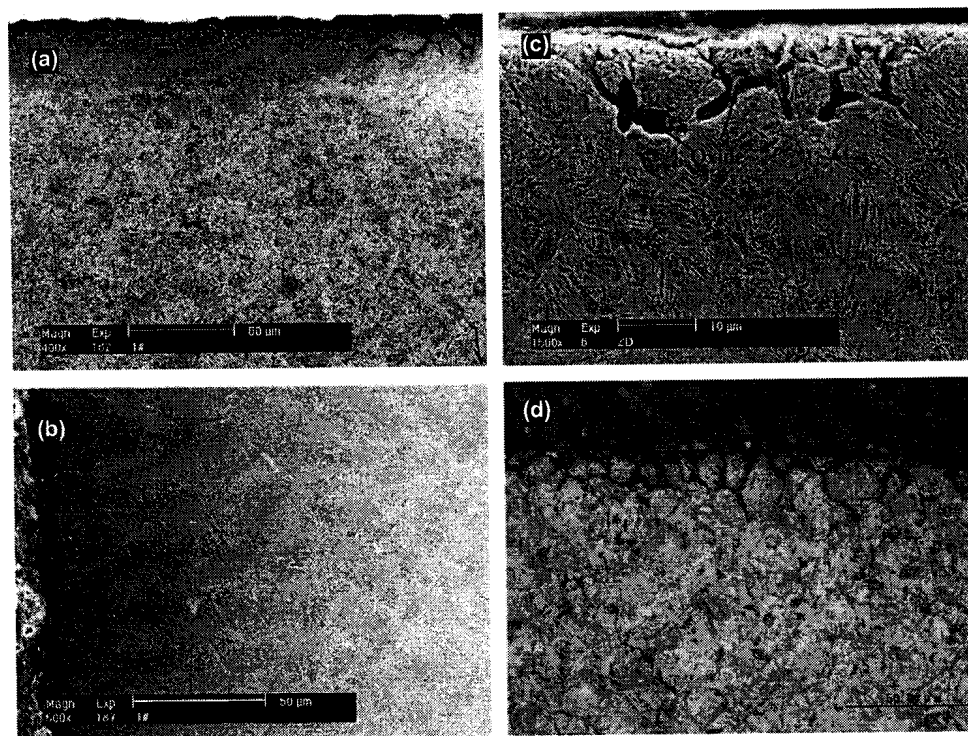
Longitudinal and transverse sectional microstructure was observed by SEM. It was found that black intergranular network-like structure is presented in the carburized layer of the external surface and the internal hole surface of the splined-shaft. Representative morphology is shown in Fig. 7a and b. Precipitates were seen along the grain boundaries (Fig. 7c). As proved by EDS analysis these precipitates are oxide compounds of Cr, Mn, and Si (Fig. 8a). It is suggested that the internal oxidation near the surface occurred, which is a typical phenomenon in gas carburized steel [5]. The depth of internal oxidation is approximately 20  $\mu\text{m}$ . It is highlighted that the region of internal oxidation presents grain boundary "cavities". OPM observation (Fig. 7d) indicates that a thin film of "dark component" (about 1  $\mu\text{m}$  thick) alongside grain boundaries is revealed in the internal oxidation layer by slightly etching in 0.4% solution of nitric acid in alcohol [6], whose metallographic features is identical with non-martensite as described in the literatures [5–7], troosite or pearlite. The microstructure of carburized layer is mainly composed of the tempered plate-martensite and the retained austenite without intergranular network-like carbides. The microstructure of core is tempered lath-martensite.

It is noted that no decarburization was observed on the surface, in spite of presence of intergranular internal oxidation in the carburized layer. The susceptibility of different elements to oxidation can be determined by the oxidation potential  $P_0$ . Ref. [6] gives the calculated values of the internal oxidation potential for reactions and it can be seen that on heating to 930  $^{\circ}\text{C}$  in an endothermic atmosphere Si, Mn, and Cr are oxidized, while iron are not oxidized. Therefore, "external oxidation" of matrix of steel did not take place, but internal oxidation of other elements Cr, Mn, Si occurred at the boundary.

**Fig. 7.** Microstructure of carburized layer: (a) showing internal oxidation morphology (tip region), (b) showing of internal oxidation morphology (internal hole surface), (c) showing oxides in the grain boundaries in internal oxidation zone, and (d) showing morphology non-martensite thin film alongside the grain boundary in the internal oxidation zone by slightly etching (OPM).

- (1) Exchange the material of splined-shaft and select the steels containing alloy elements (e.g. Mo, Ni) unsusceptible for internal oxidation. Reduce the content of gases containing oxygen in the furnace.
- (2) Improve the design of the splined-shaft and obtain a suitable transition between the tooth portion and shaft portion to decrease the degree of stress concentration.

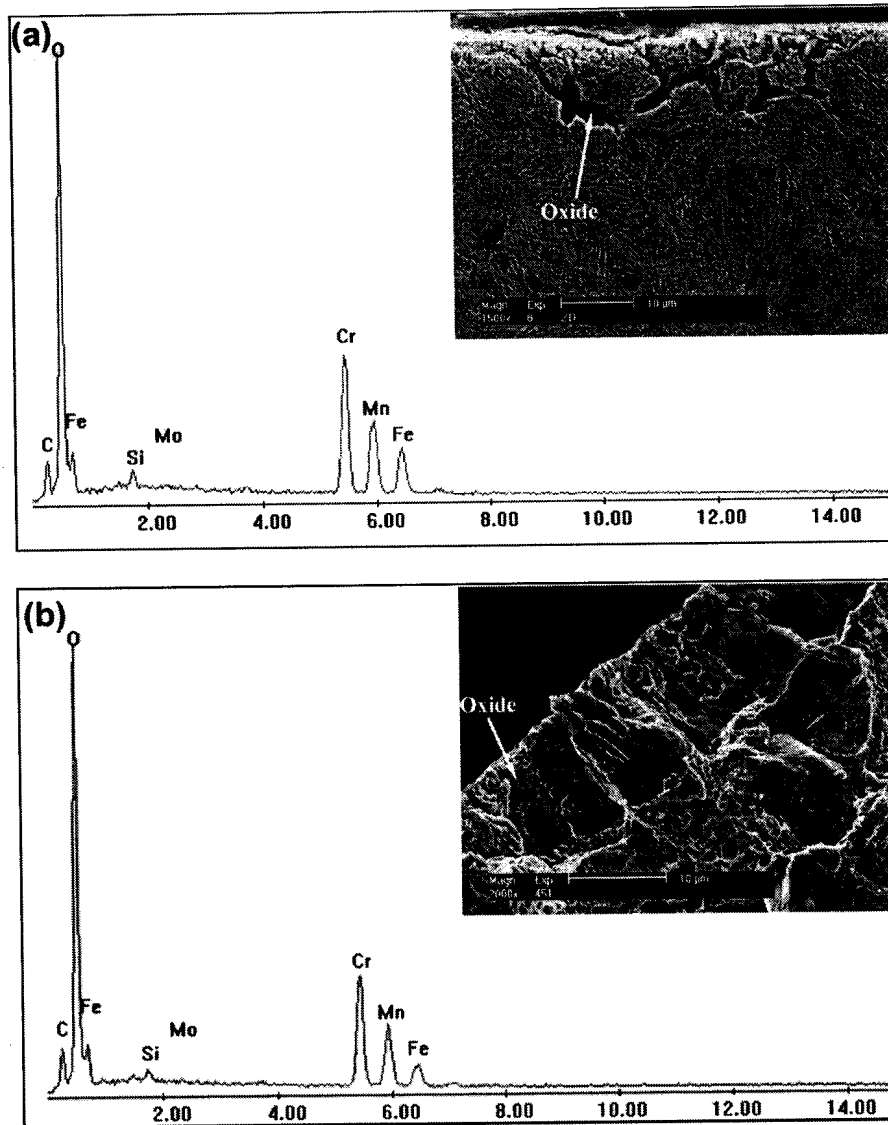
Fig. 8. EDS analysis of precipitates in the case layer and on the intergranular facets: (a) precipitates along the boundaries and (b) precipitates on the intergranular facets.

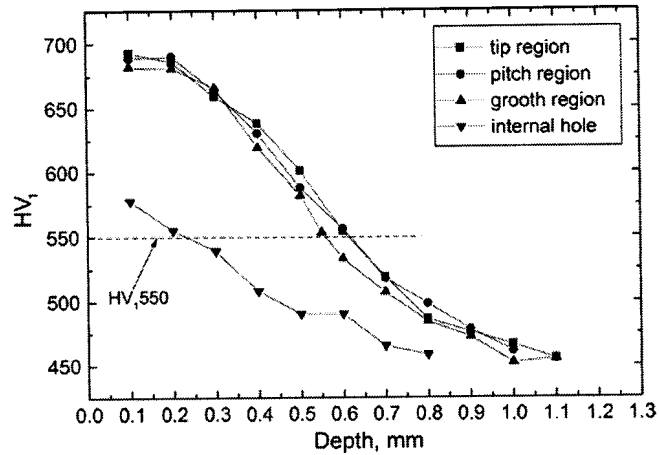
The surface hardness is HV<sub>10</sub> 719 (average value of three readings), which is in accordance with the specified (HV<sub>10</sub> 675–770). The hardness profiles in the tip, pitch line, groove and internal hole regions from the surface to the interior were measured (Fig. 9). It can be seen that the case depth of the tooth portion is generally about 0.55–0.62 mm, which corresponds to the specified (0.30–0.80 mm), and the case depth of internal hole is relatively shallow, about 0.20 mm.

Fig. 9. Micro-hardness profiles in various region.

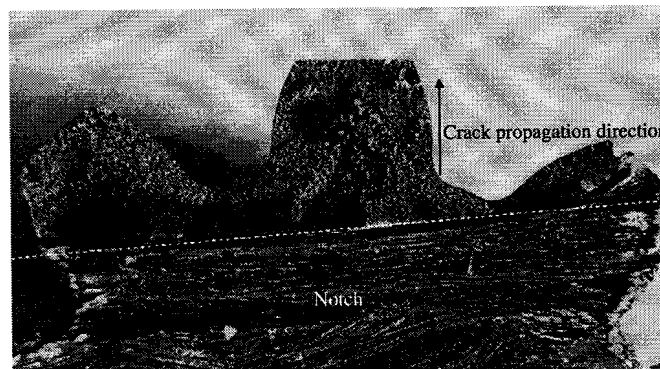
Fig. 10. Macro-fracture manufactured artificially.

tures on the fracture surface of internal hole implies some brittle failure mechanism occurred on the splined-shaft and the brittle fracture maybe relates to the case layer on the splined-shaft. To investigation the relation of intergranular fracture to the case-layer, a fracture was manufactured artificially. The semicircle transverse section was removed from the tooth portion and a transverse notch was made in the matrix by spark-cutting, then breaking off the section from the matrix toward the tooth portion to obtain identical orientation fracture with the original fracture of the failed splined-shaft. Fig. 10 shows a macrograph of fracture in the laboratory. Low-magnified SEM observation indicates that the fracture surface has a different appearance in the outer and inner regions. In the outer region of 0.7–0.8 mm from the surface the fracture surface is brittle but ductile in the tooth center (Fig. 11a). High-magnified SEM observation reveals that in the carburized area of about 0.5 mm from the surface the fracture mode is predominately intergranular (Fig. 11b). An obvious interface is revealed at the location of about 20  $\mu\text{m}$  from the surface (marked in Fig. 11c). However, a close examination of Fig. 11d shows particle-like or rod-like substances at the intergranular facets. As proved by EDS analysis these substances are also oxide compounds of Cr, Mn, and Si (Fig. 8b), in accordance with the precipitates at the grain boundaries of the case layer. It is highlighted that dimples or ductile tears were observed at separated grain facets (Fig. 11d). The fractographic features are similar to those presented in the internal hole region of the failed splined-shaft. This indicates that the cracking occurred by microvoid coalescence alongside grain boundaries typical of a crack propagation by a ductile intergranular mode [10,11]. This behavior is known to results from highly localized plastic deformation within relatively “soft” zones alongside grain boundaries [12], e.g. troosite or pearlite network [5]. It is well known that the occurrence of the internal oxidation on the carburized layer can induce the formation of non-martensitic structure alongside the grain boundaries, e.g. pearlite, troosite or bainite. The appearance of dimples or ductile tears on the intergranular facets further demonstrates that a thin film of non-martensitic structure formed alongside the grain boundaries. The presence of non-martensite structure alongside grain boundaries becomes relatively “softer” than the plate martensite. In summary, the above results indicate that the fracture mechanism was ductile intergranular cracking related to precipitation of intergranular oxides. The oxide particles are not presented on the intergranular facets in subsurface, but dimples were still observed on the individual intergranular facets (Fig. 11e). The middle region of tooth is characterized by a dimpled ductile fracture (Fig. 11f).

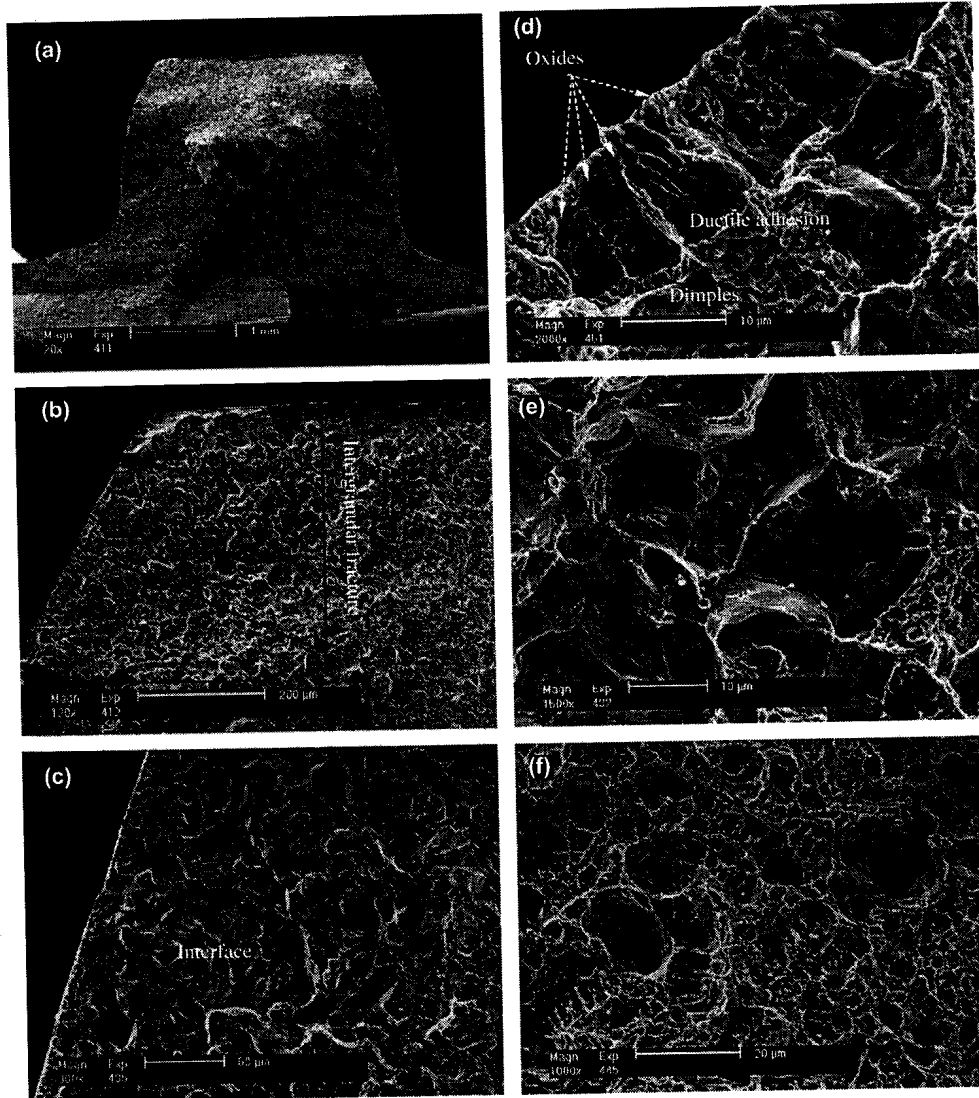
**Fig. 11.** SEM observation on the fracture surface prepared artificially: (a) general view, (b) showing intergranular fracture zone, (c) showing the interface corresponding to internal oxidation zone, (d) showing intergranular facets associated with the oxides and dimples, (e) showing intergranular fracture in subsurface, and (f) showing dimple morphology in the middle region.

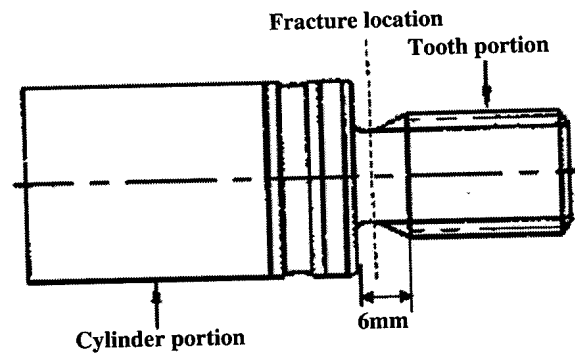
Fig. 12. The scheme of splined-shaft.

It should be pointed that the presence of intergranular internal oxidation in the case layer is not enough to cause the splined-shaft to rupture prematurely. However, in combination with greater stress concentration at the fracture location resulting from over-short axial free length between the tooth portion and the cylinder portion, the probability of such an event is considerably increased. Similar failure did not occur on another type of splined-shaft which have a suitable transition between the tooth and the cylinder (Fig. 13), despite of occurrence of internal oxidation in the case-layer.

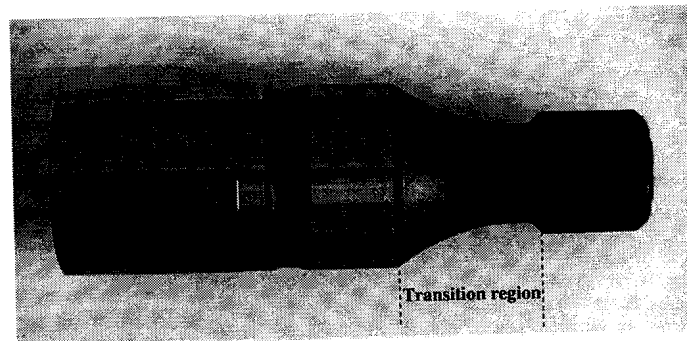
Fig. 13. Splined-shaft with suitable transition between the tooth and the shaft.
