วิชา 237-407 Failure Mechanics and Analysis

Case Study : Failure Analysis of Diesel Engine Cylinder Head Bolts

Engineering Failure Analysis 13 (2006) 826–834

Failure analysis of diesel engine cylinder head bolts

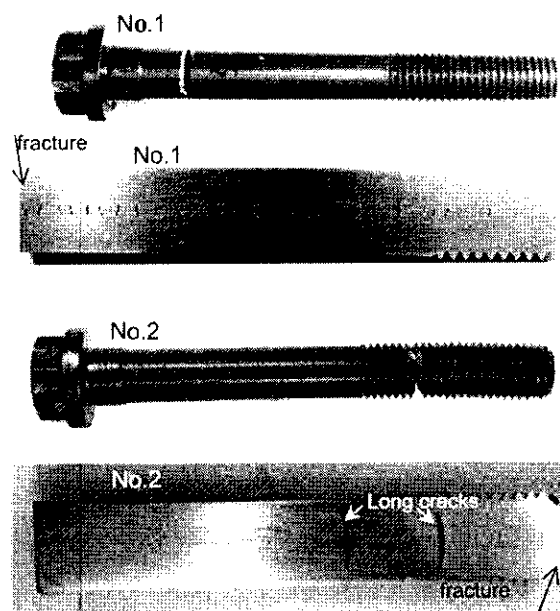
The failed bolts are shown in Fig. 1. For bolt No. 1, the fracture had taken place on the smooth rod other than the threaded end although it is not the position bearing the greater stress. According to the friction trail by initial tightening, the fracture took place when initial tightening to the third thread and there is no friction trail on the contact surface of the head. It indicates that the bolt No. 1 had fractured as bolts were not tightened up. For bolt No. 2, the fracture had take place at the 18th thread. According to the friction trail by initial tightening, the initial tightening position should be the 16th thread, usually which should

Fig. 1. Failed bolts and longitudinal section showing radial cracks.

be the normal initial position. It is indicated that both bolts did not fracture at the position with the greatest stress. It is suggested that the tensile strength of the bolts at the fracture position are very low.

The longitudinal sections of the fractured bolts show similar characteristics that tens stripe of the radial cracks appear in the centre region of the rod along the axial orientation (Fig. 1). For bolt No. 1, 38 strips radial cracks 1.5–2.0 mm long are distributed on the rod in an almost equal distance. The crack at the fracture should be the longest crack. For bolt No. 2, there are two strips crescent-like long cracks (at arrows). From the distance between the long cracks and the distance of the fracture surface from the long crack, it can be inferred that the length of the crack at the fracture is equal to that of both cracks. Fourty four strips short radial cracks about 1 mm long are distributed homogeneously in the centre region. All the cracks, no matter long or short, exhibit plate-like morphology in three dimension. If the longitudinal sections were etched by HNO_3 , it can be found that there is a dark band along axial orientation in the centre of the rod.

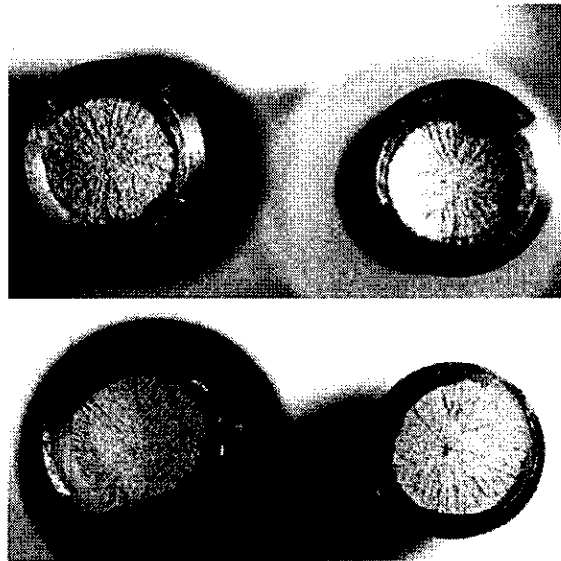
Macrograph of the fracture surfaces of the failed bolts are shown in Fig. 2. There is no plastic deformation on the fractures and 45° shear lip can be observed on the outer fringe zone of the fractures. It can be seen that the fractures exhibit radiative patterns (Fig. 2). According to the extending trail of the fracture, it can be determined that the crack initiated from the centre zone and radially propagated toward the outer zone.

Fig. 2. The fracture surfaces of the failed bolt.

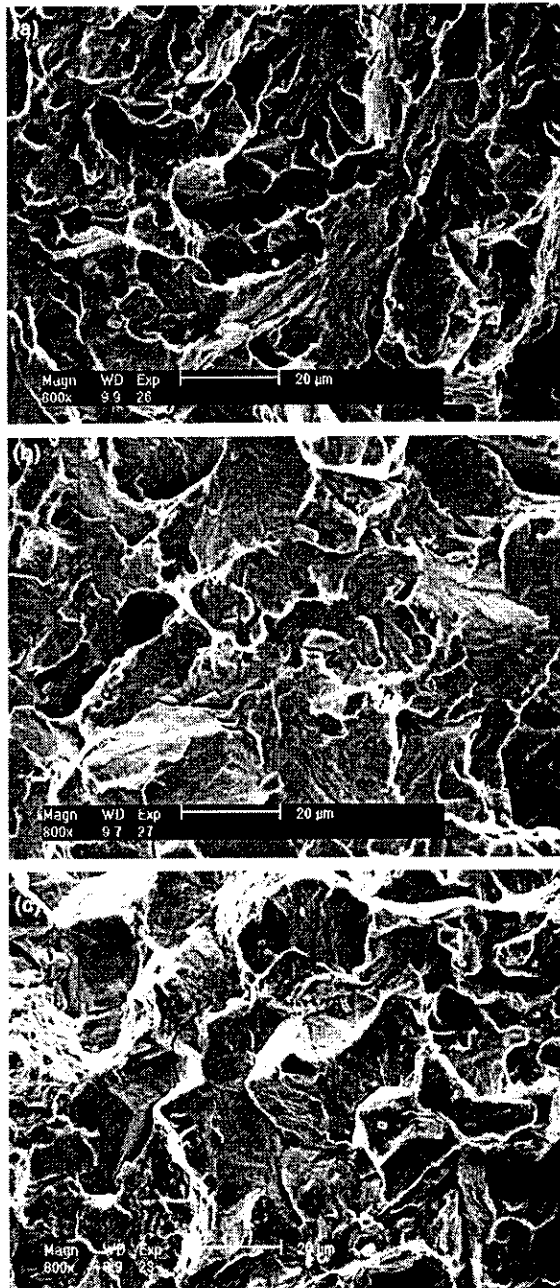
A penetrating investigation of fracture surfaces in various regions was performed by SEM. Similar microscopic features were seen. The fractures mainly show brittle cleavage and quasi-cleavage features (Figs. 3(a) and (b)). It should be noted that intergranular brittle fracture morphology appears on the local zone of the fracture centre for bolt No. 1 (Fig. 3(c)), which may result from the P and other impurity elements segregation at the grain boundary [1].

Fig. 3. SEM fractographs of the failed bolts: (a,b) cleavage and quasi-cleavage patterns (No. 1, No. 2), (c) intergranular morphology (No. 1).

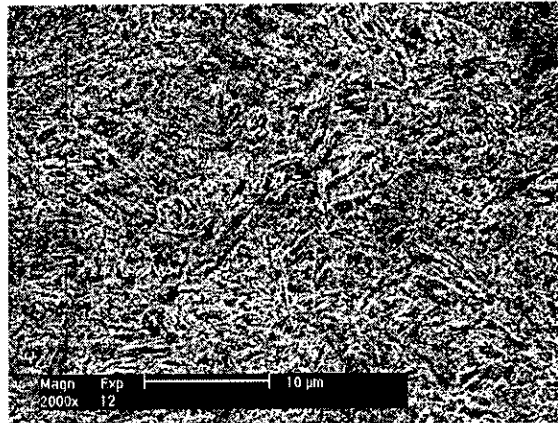
Longitudinal and transverse microstructure at various locations of the bolts revealed a tempered sorbite (Fig. 4). This type of microstructure is expected from this grade of steel [3].

Fig. 4. Microstructure of the material of the failed bolt.

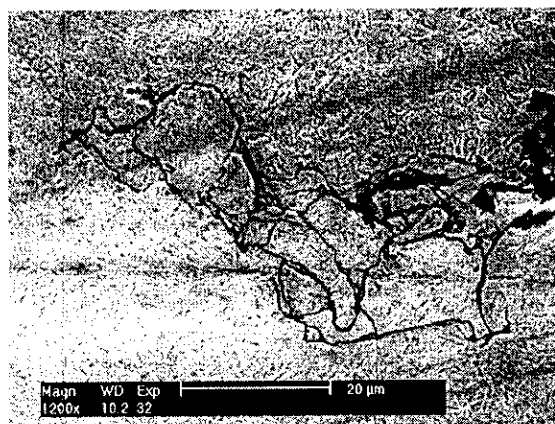
A lot of intergranular and network micro-cracks appear in the zone of the crack tip (Fig. 5), which were formed during quenching.

Fig. 5. Micro-cracks and network cracks.

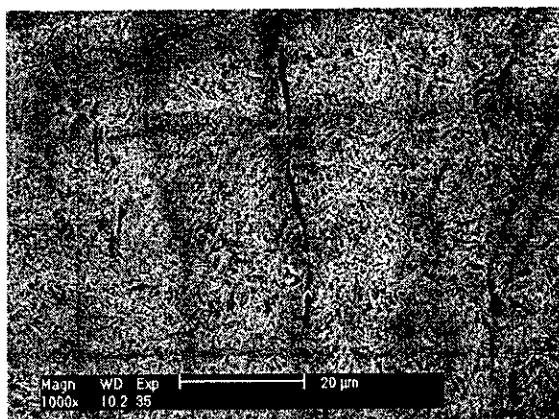
In Fig. 6, stringers of elongated inclusions in the material of the bolts are observable in the region between the cracks. These were revealed to be the MnS through EDX analysis (Table 1). MnS inclusions are frequently found elongated along the longitudinal direction in a drawn component.

Fig. 6. MnS inclusions morphology.

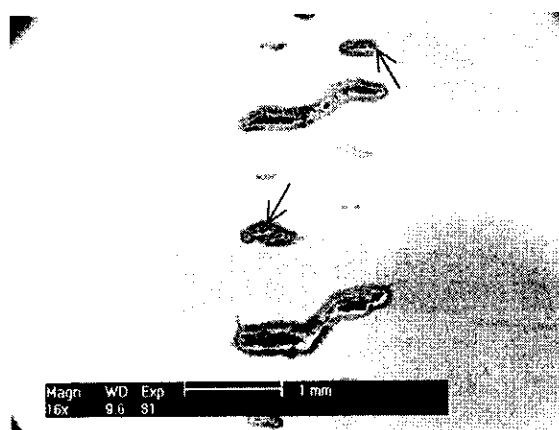
The micro-morphology of the cracks was observed by SEM. It can be seen that there are shorter cracks (at arrows) between the cracks 1.5–2.0 mm long by visual for bolt No. 1 (Fig. 7). Both ends of the longer crack are sharper (Fig. 8), which are the same for bolt No. 2.

Fig. 7. SEM observation on the cracks (No. 1).

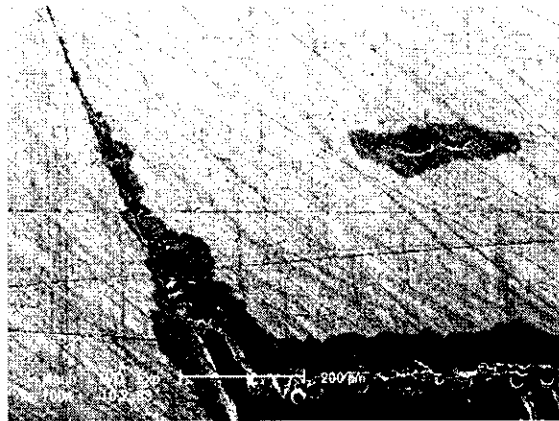
Fig. 8. Micro morphology of cracks (No. 1).

When quenching, the stress concentration around cracks tip would lead to the formation of the network quenching micro-cracks. The original cracks would propagate further and their tips would become sharper. The presence of the long and short cracks in the centre zone reduces the effective loading area of the bolt. So shearing fracture would take place at the weakest position with longest crack when initial tightening.

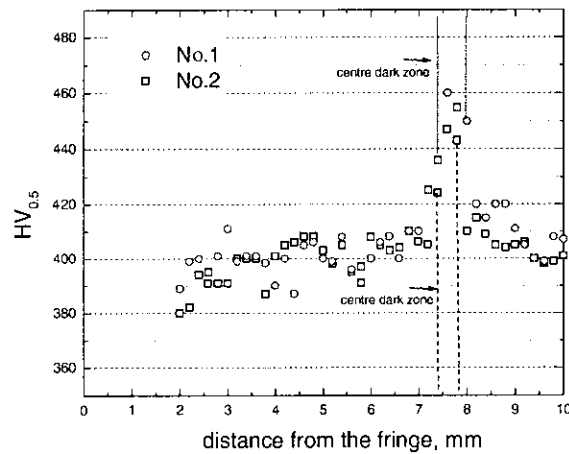
The average macro-hardness of the failed bolts was conducted to be, respectively, 39.5 and 39.0, which correspond to the specified range (HRC 39–44). The microhardness ($HV_{0.5}$) profiles along radial direction on the longitudinal section of the bolts were measured (Fig. 9). It is clear that, despite some scatter, higher micro-hardness zone can be found for both failed bolts, which should correspond to the dark zone in the centre of the bolt. Appearance of the higher microhardness zone may result from the carbon segregation.

Fig. 9. Micro-hardness profiles of radial direction on the longitudinal section.

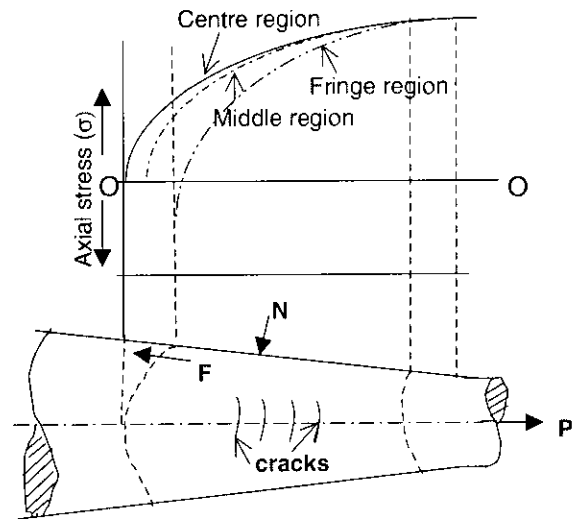
The diagrammatic sketch of force acting on the drawn rod and axial tensile stress profile along the axial direction of the drawn rod is shown in Fig. 10, three forces are acted on the rod: the tensile force at the ahead end of the rod, P ; normal compressive force, N and surface friction, F by mould. Three forces make the drawn rod bear three-dimensional stress state, which are axial tensile stress, radial and circumferential compressive stress. According to the theory of plastic deformation process, axial tensile stress in the centre zone is greater than that in the fringe zone. However, the presence of the carbon segregation and metallurgical inclusions in the centre zone of the rod reduce intensely the plasticity of the material so as to the radial plate-like cracks formed in centre zone of the drawn rod.

With the initiation and propagation of the radial long crack the tensile stress would be relaxed. However, the tensile stress would increase again with continuous drawing. When the stress in the local region attained to the strength limit at this position, the new crack formed again. The long or short radial cracks are distributed periodically in the centre zone of the rod along the axial orientation. Long crack had formed before short cracks appeared.

Fig. 10. Diagrammatic sketch of force acting on the drawn rod and axial tensile stress profile.
