การสอบปลายภาค ประจำภาคการศึกษาที่ 1
 วันที่ 15 ธันวาคม 2558
 วิชา 237-407 Failure Mechanics and Analysis

Case Study : Failure Analysis of Hydraulic Turbine Shaft

โรงไฟฟ้าพลังน้ำของประเทศ Serbia ถูกออกแบบให้ติดตั้ง Hydro Turbine แบบ KAPLAN ขนาดเครื่องละ 28 MW จำนวน 9 ชุด

Failure analysis of hydraulic turbine shaft

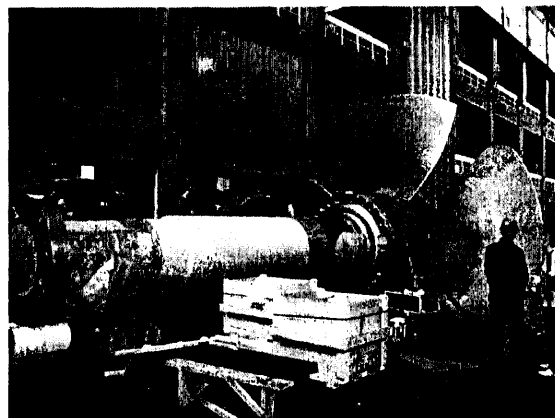
Fig. 1. Disassembled turbine shaft with runner.

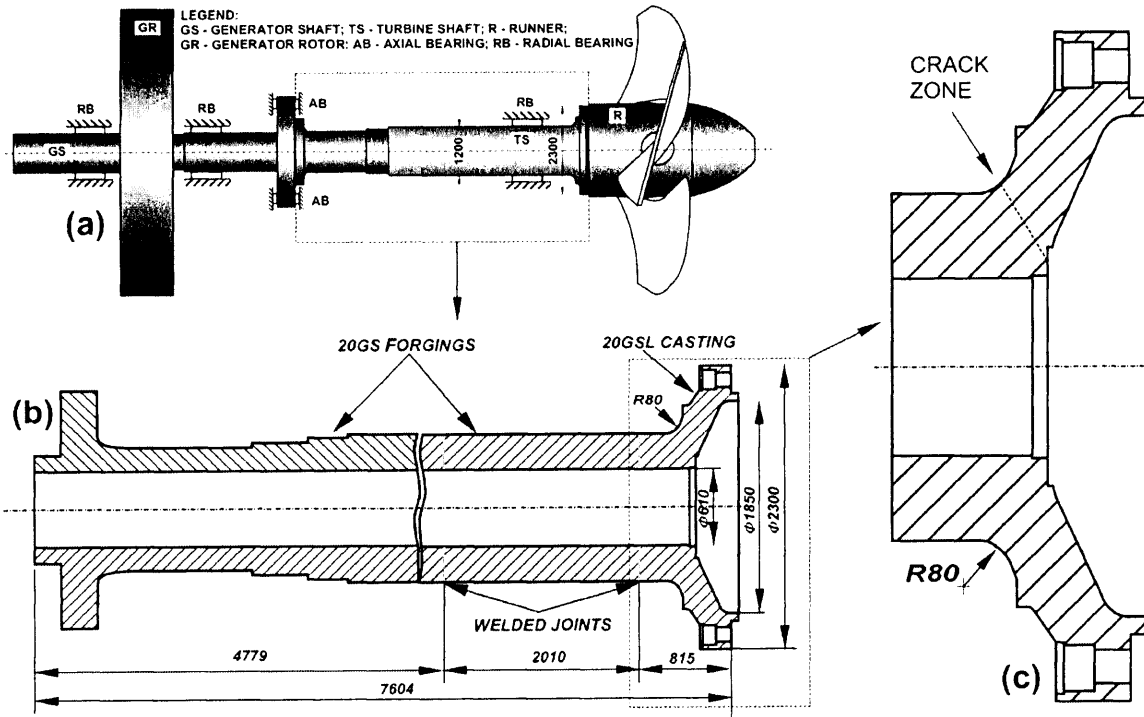
Fig. 2. Position of crack on general assembly of hydraulic turbine shaft: (a) schematic presentation of generator, (b) longitudinal cross section of the hollow shaft, and (c) longitudinal cross section of flange with crack detection zone.

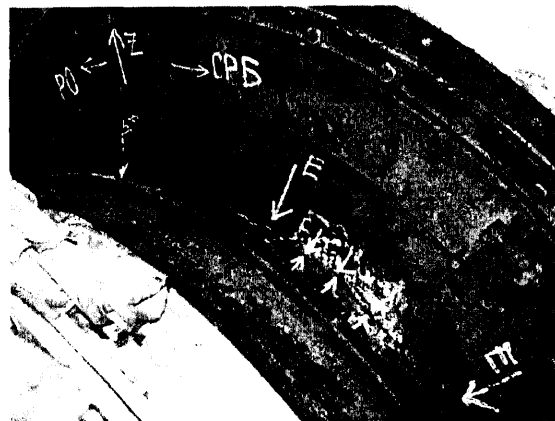
Fig. 3. General appearance of the cracked zone.

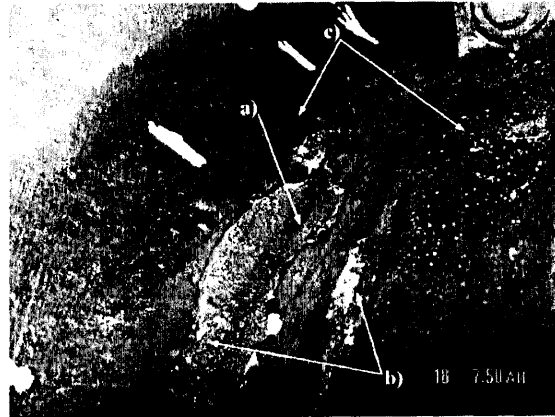
Fig. 4. Close view of the transient flange radius after detecting the crack: (a) main crack, (b) anti-corrosive protection layer, and (c) oil residue on corrosion pits.

It was determined by visual inspection that the anticorrosive coating was delaminated from the metal surface and that the zone of the shaft-flange transition radius was directly exposed to the effects of river water due to inadequate sealing of the shaft seal box.

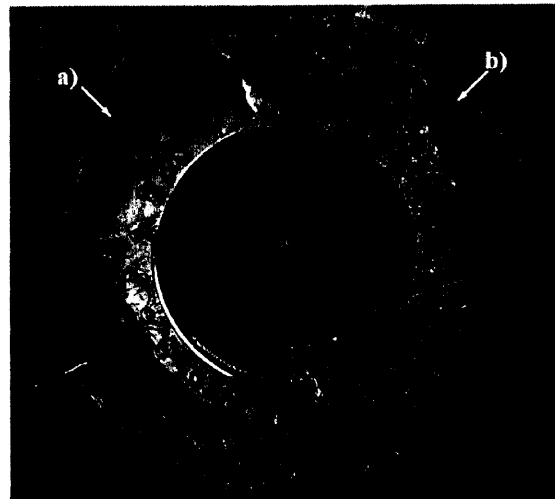
Fig. 5. Transversal cross section of the hollow shaft: (a) fractured zone of through wall crack on the hollow shaft and (b) flame cut zone of the shaft.

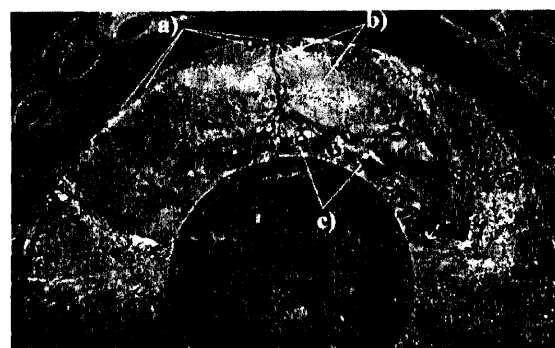
On the basis of visual examination of the crack surface, the multiple fatigue cracks initiations sites were perceived, as shown in Fig. 6, (zone a). In the same figure, the zone of the stable fatigue crack propagation front, (zone b), and the final phase of instable crack growth are observed. In Fig. 6, (zone c), openings were perceived that had been drilled by mistake in some phase of the flange manufacture. The Fig. 7a and b shows the magnified view of the crack surface zones. Fig. 7a shows front view of fractured surface where are quite obvious ratchet marks that occurred as the result of linking the propagation fronts of several fatigue cracks, as well as the stable growth zone. Fig. 7b shows side view of shaft radius with secondary cracks. On the fracture surface, the visible distorted fatigue lines around numerous gas holes and locations of increased porosity are observed, Fig. 8.

The overall appearance of the examined crack surface indicates that the fracture occurred due to combined actions of twisting and bending. The small slant angle of the fatigue surface points to the influence of torsion stresses on cracks formation was less influential than the effects of the stress due to bending or tension. It can be seen in Figs. 5 and 6 that the through crack makes almost 30% of the total cross section of the shaft, so it is obvious that operating stresses in the fracture zone were small [7].

Fig. 6. General appearance of fractured surface: (a) multiple fatigue cracks initiations sites, (b) stable fatigue crack propagation front, and (c) drilled holes.

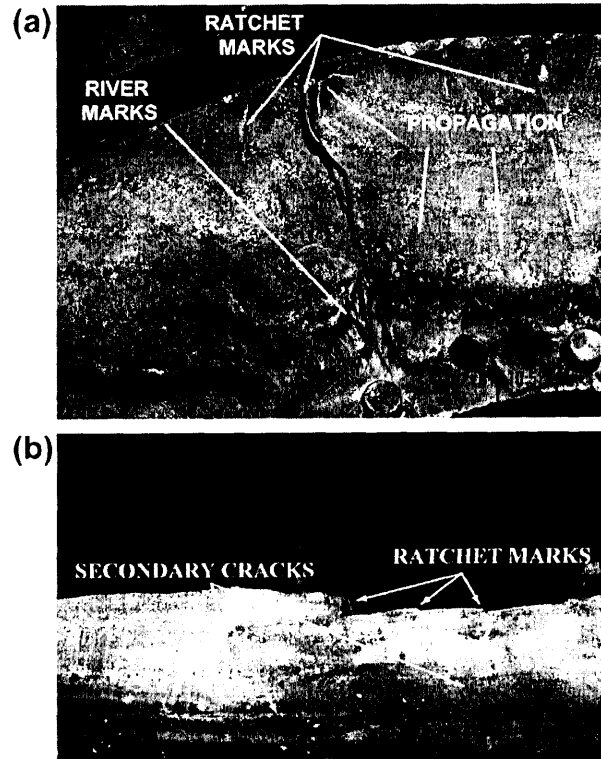
Fig. 7. Multiple crack initiation sites with ratchet marks: (a) front view and (b) side view.

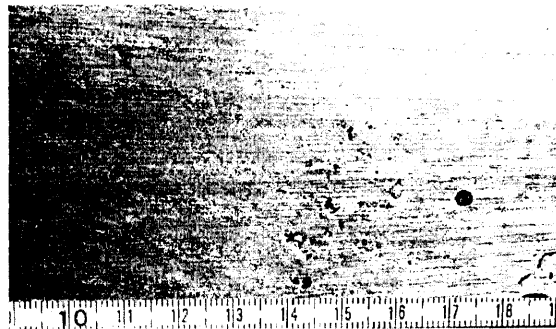
During cutting of samples for the mechanical and metallographic tests, numerous gas holes and pores were detected that resulted from the casting process, Fig. 9. Gas pores and holes were not perceived around the crack initiation location, i.e. around the outer shaft surface, but exclusively in the casting volume.

Fig. 9. Gas holes and shrinkages on casting, zone near shaft-flange transition radius.

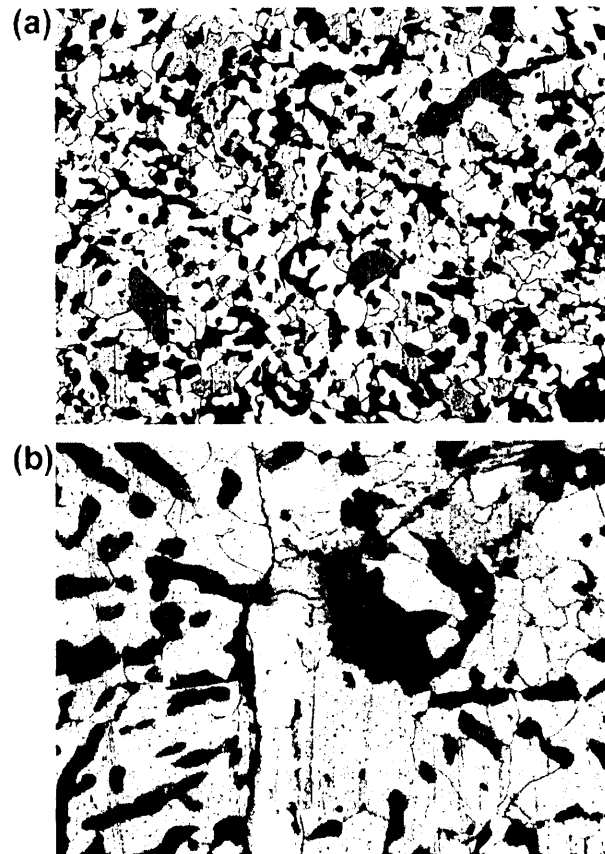
However, the microstructure of the material is the cast ferrite-pearlite one, with oxide type non-metallic inclusions and with minimal participation of dendrite structure, Fig. 11a. Dendrite structure presence points to the possibility of incomplete or irregularly executed shaft flange heat treatment, which explains the observed scatter of results in all the mechanical tests. It was also determined that there were large non-metallic oxide inclusions in the structure, which occurred in sequences. The fine microcracks were found in microstructure, Fig. 11b.

Fig. 11. Microstructure of flange material: (a). Cast, ferrite-pearlite microstructure, $\times 200$, 5% nital, and (b). Microcracks emanating from shrinkage, $\times 500$, 5% nital.

The presence of dendrite structure points to incomplete or irregular flange heat treatment. Moreover, microstructure and subsequent data scatter indicated that the heat treatment regime had some influence in the fracture process.

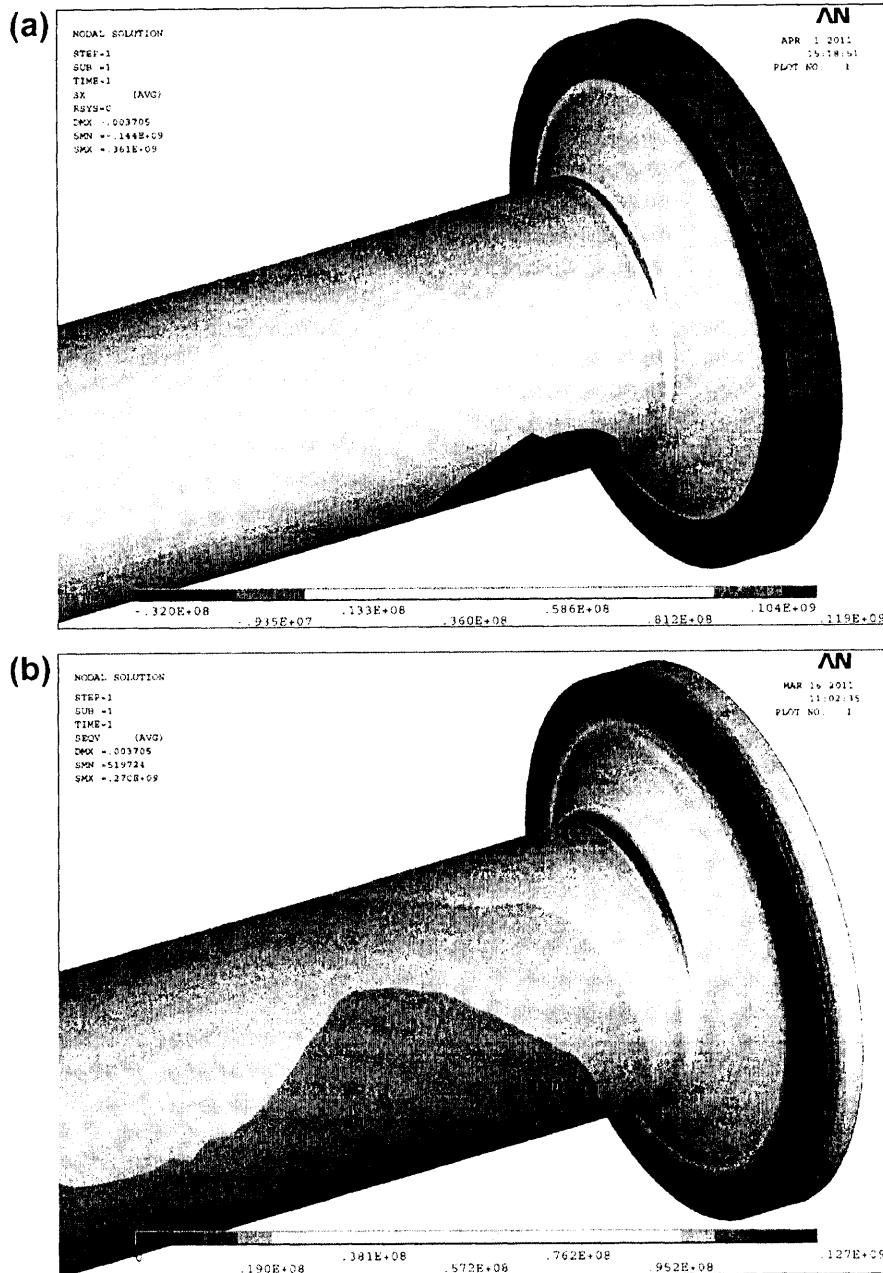
Fig. 15 shows the stresses, calculated by the finite elements method, at the location of crack initiation at the shaft flange, for the load case 1. Fig. 15a shows the stress contours of the normal tension stresses in the direction of the shaft axis σ_x , while Fig. 15b shows the equivalent stresses σ_{eqv} in the same zone, calculated according to the Von Mises's criterion. From the stress contours display maximum normal stress $\sigma_x = 119$ MPa and the maximum equivalent stress $\sigma_{eqv} = 127$ MPa can be read in the same node on the flange radius, which corresponds to the real location of cracks initiation, Figs. 2–4.

Fig. 15. Finite element analysis results for the load case 1, (Pa).

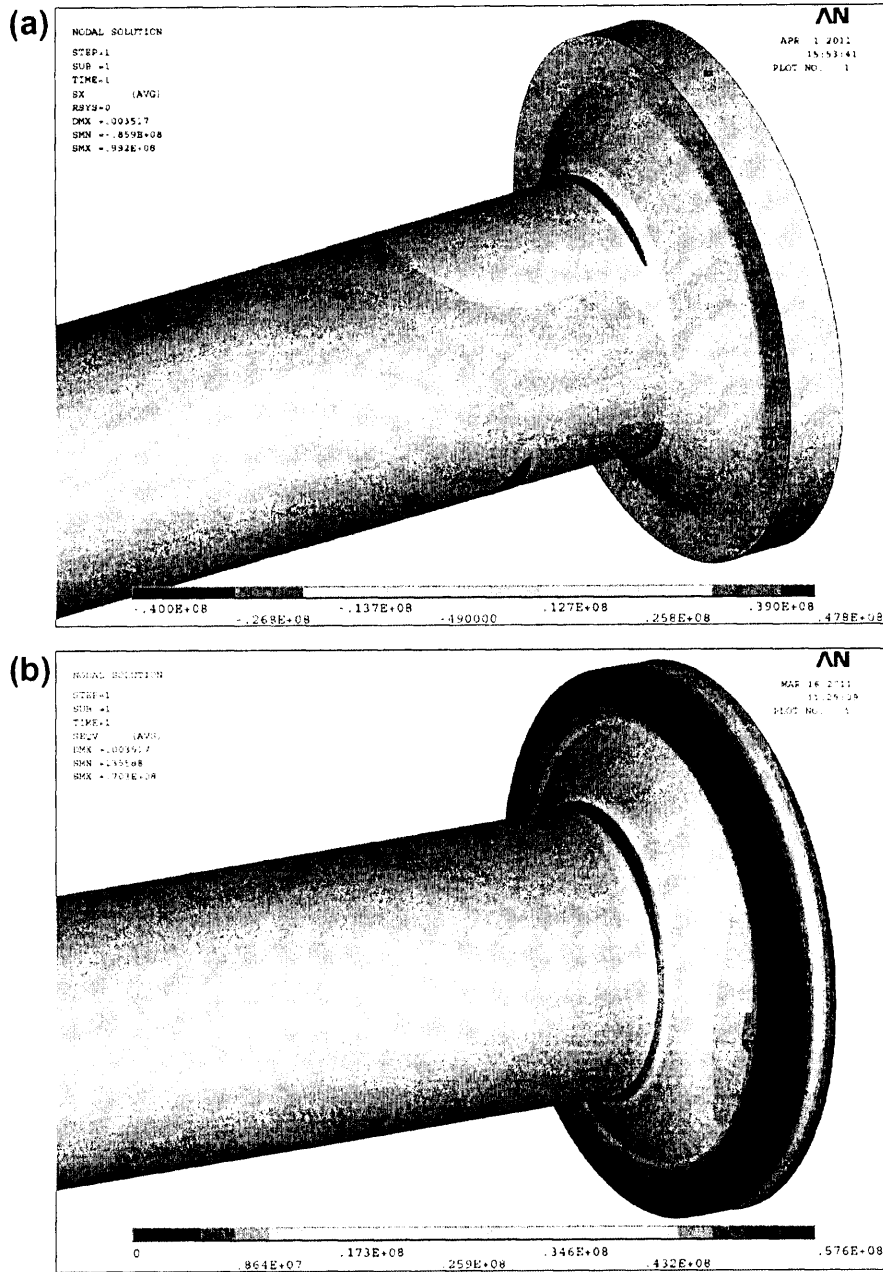
Fig. 16 shows the stresses, at the location of crack initiation at shaft flange, for the load case 2. Fig. 16a shows the stress contours of the normal tension stresses in the direction of shaft axis σ_x , while Fig. 16b shows equivalent stresses σ_{eqv} in the same zone, calculated according to the Von Mises' criterion. From the stress contours display the maximum normal stresses $\sigma_x = 47.8$ MPa, $\sigma_y = 12.5$ MPa and the maximum equivalent stress $\sigma_{eqv} = 57$ MPa can be read in the same node on the flange radius, which corresponds to the real crack initiation location, Figs. 2–4.

Fig. 16. Finite element analysis results for the load case 2, (Pa).

Also, the tensile stress values on the shaft-flange transition radius, obtained by the Finite element analysis, for the load case 2 (47.8 MPa) are higher than the recommended one (≤ 40 MPa) for this type of shafts [15,16].

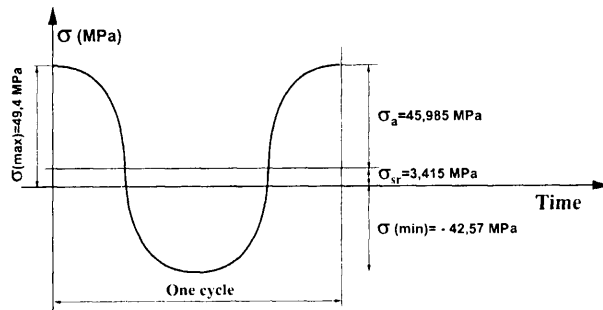
The change of the total normal stress $\sigma_n = \sqrt{\sigma_x^2 + \sigma_y^2}$ in the node of FEM mesh at the flange radius in which the maximum stresses occur (the equivalent and total normal load) is shown in Fig. 17 for one rotation of the shaft, i.e. one load change cycle. The maximum stress value σ (max) occurs when the monitoring node is on the top position during shaft rotation, and σ (min) occurs when the monitoring node is on the bottom position during shaft rotation. It can be seen from the diagram in Fig. 17 that the stress ratio is: $R = \sigma(\max)/\sigma(\min) = -0.86$. Also, the average total normal stress value is calculated by expression: $\sigma_{sr} = (\sigma(\max) + \sigma(\min))/2$ and shown in Fig. 17.

Fig. 17. Total normal stresses in the course of one revolution.
