วิชา 237-407 Failure Mechanics and Analysis

## แบบทดสอบการวิเคราะห์การชำรุดอย่างเป็นระบบ ปีการศึกษา 2557

**Case Study : Elevator Chain Wheel Shaft Break Analysis**

## Elevator chain wheel shaft break analysis

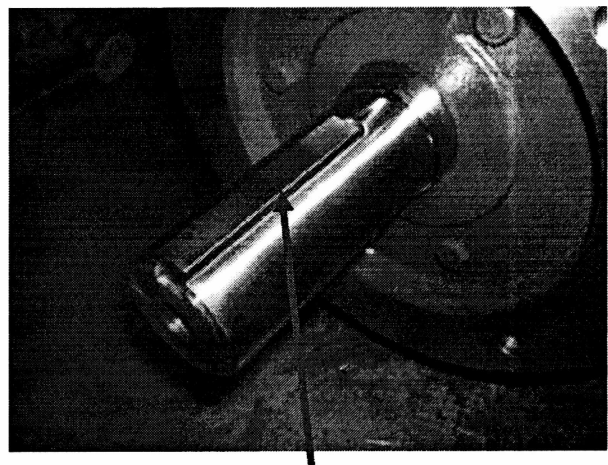
Wedge or Key (ลิ้ม)

Keyway(ร่องลิ้ม)

The basic cause of a minor damage occurring on the surface of the shaft is inaccuracy of the keyway and wedge manufacture, and an imperfect matching of diameters shown by a minimal shift between the edges of the keyway on the shaft and on the hub of the gear-wheel (Fig. 2). The indentation and formation of a surface notch in the shaft may have occurred during installation of the gear-wheel to the shaft or at the first start-up of the electro-motor. If the damage occurred at the device start-up, it was a result of the clearance between the wedge and the keyway in the chain wheel hub (during the device start-up, the shaft, compared to the gear-wheel hub, for a moment ran "idle"; since the shaft turned to left, the edge of the keyway on the gear-wheel hub, compared to the edge of the keyway on the shaft, slightly shifted to the right).
