วิชา 237-407 Failure Mechanics and Analysis

**Case Study : Failure investigation on the cracked crawler pad link**

## Failure investigation on the cracked crawler pad link

An in-service failure of traveling gear crawler pad occurred on dredger. Inspection revealed cracking of two links that connect individual pads together. Intergranular brittle fracture occurred on the links and a significant amount of chain-like and rod-like AlN inclusions were found on the intergranular fracture surfaces. Examination of mechanical properties indicates that the plasticity and impact toughness of link material are considerably lower than the specified values, indicating the brittle nature of link material. The presence of intergranular AlN inclusions resulting from considerably excessive aluminum content in link material is responsible for the brittle nature of link material. The presence of shrinkage cavities facilitated the cracking process.

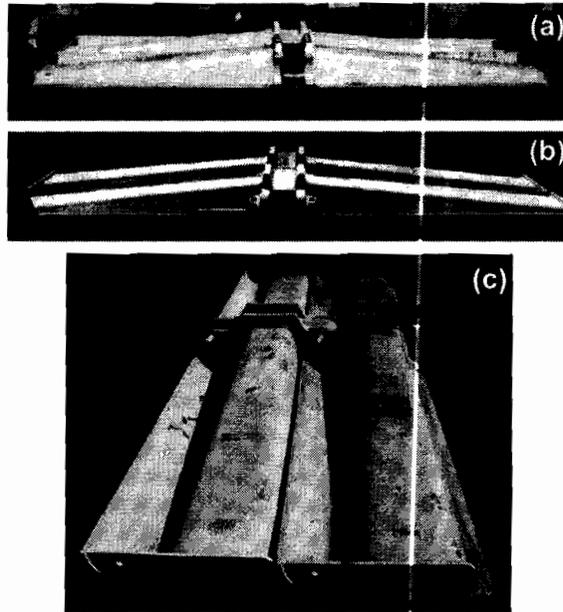
An in-service failure of traveling gear crawler pad occurred on dredger. Inspection revealed cracking of two links that connect individual pads together. The crawler pads consist of cast steel links weld joined to sheet wings (Fig. 1). The links are the components that connect traveling crawler pads together into the tracks. They are connected by a steel pin through female and male lugs on the either end of casting. The tracks, in turn, enable the dredger to move around the mine site. The link material is ZG30CrMnMoV. The specified mechanical properties are as follows:

Fig. 1. Crawler pads: (a) front view; (b) rear view; (c) side view.
