การสอบปลายภาค ประจำภาคการศึกษาที่ 1
 วันที่ 15 ธันวาคม 2558
 วิชา 237-407 Failure Mechanics and Analysis

Case Study : Failure Analysis of Hydraulic Turbine Shaft

โรงไฟฟ้าพลังน้ำของประเทศ Serbia ถูกออกแบบให้ติดตั้ง Hydro Turbine แบบ KAPLAN ขนาดเครื่องละ 28 MW จำนวน 9 ชุด

Failure analysis of hydraulic turbine shaft

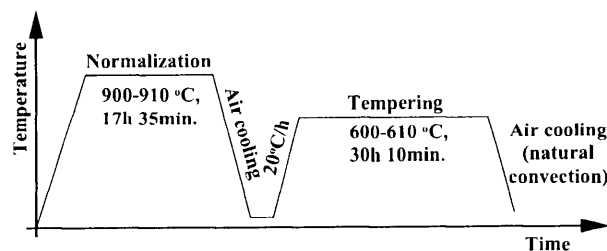
Fig. 10. Regime of applied heat treatment.

By reviewing the original documentation from the time of delivering and installing of the shaft, it was discovered that heat treatment of the shaft was done by applying the regime shown of Fig. 10:

Concerning the mechanical properties of the material, slight discrepancies were detected between the experimental results and the requirement of the specification [6]. Despite the fact that the results of tensile strength and elongation does not meet the requirements this cannot be considered as significant for the failure of turbine shaft. Fatigue limit S_{FL} of flange material (168 MPa) is approx. 25% less than required (225 MPa) according to reference values, and could be indicated as significant factor to the premature failure.

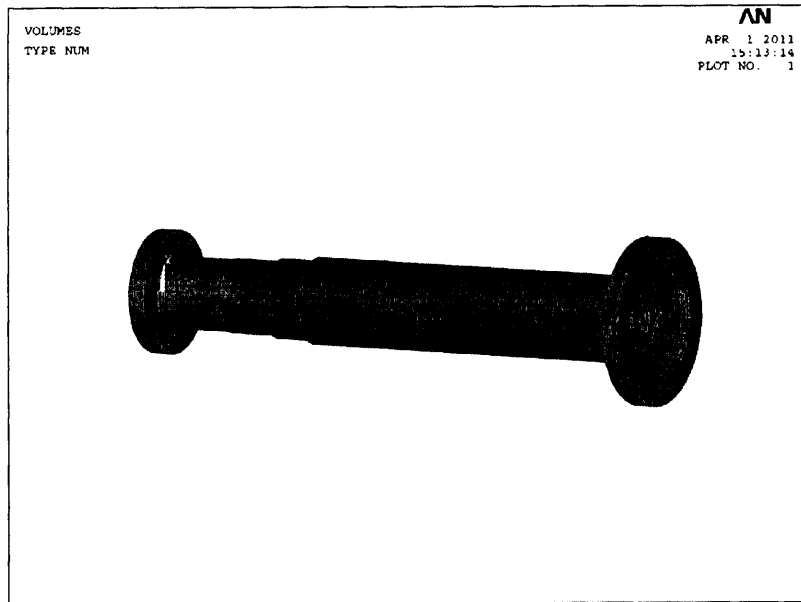
Fig. 12. 3D shaft model.

The linear Finite Elements Analysis is used for determining the stress state of turbine shaft and shaft flange attachment towards the turbine runner. The commercial ANSYS 11 software was chosen for finite element modeling. The shaft and flange dimensions have been defined by the turbine manufacturer in the original documentation, Fig. 2. The modeled 3D shaft-flange model is shown in Fig. 12.

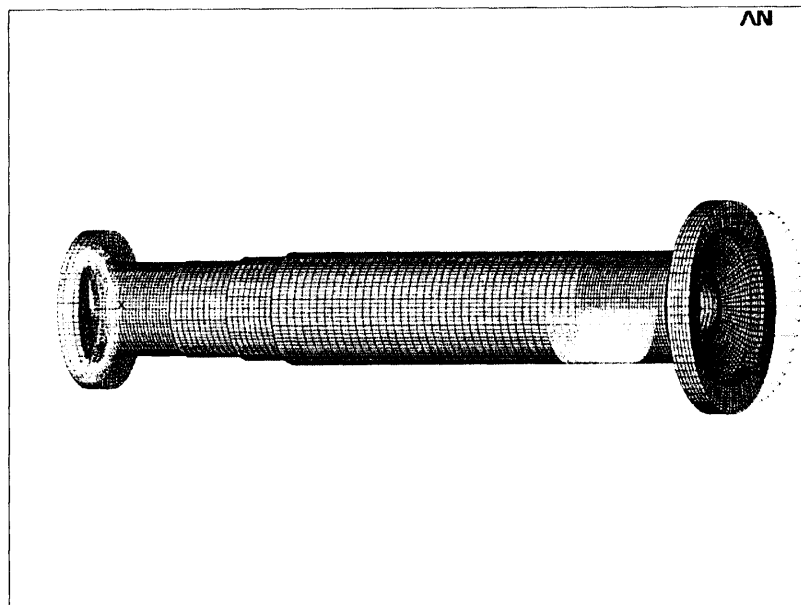
Fig. 13. Finite element model with defined boundary conditions and external loads for the load case 1.

flange. For modeling the elements to which the shaft is connected (generator shaft and turbine runner), boundary conditions have been defined on the model, as shown in Fig. 13: radial movements in the nodes in contact with sliding radial bearing and all movements at the flange attachment towards generator shaft.

Load case 1, Fig. 13, corresponds to the static load during start up regime of operation with the shift of the runner blades and it is defined by: the maximum axial hydraulic force of $F_a = 5542.65 \times 10^3$ N, pressure in servomotor of $q = 40$ bar, own shaft's weight, runner's weight of $1 \cdot 10^6$ N and the torque on the runner of $M_t = 4280.5935 \times 10^3$ Nm.

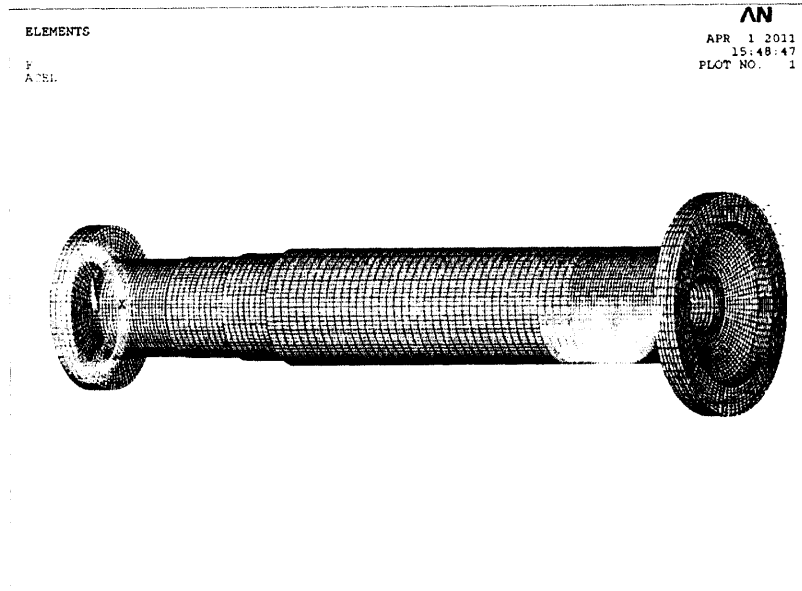
Fig. 14. Finite element model with defined boundary conditions and external loads for the load case 2.

Load case 2, Fig. 14, corresponds to the dynamic, time-variable load in the course of normal operating regime and it is defined by: axial hydraulic force of $F_a = 392.4 \times 10^3$ N, own shaft's weight, runner's weight of 1×10^6 N and the torque on the runner of $M_t = 4280.5935 \times 10^3$ Nm.
